APPENDIX E
THREATENED AND ENDANGERED SPECIES
REPORTS

Survey of Stream Fish Habitat at Five Potential Bridge Crossing Sites for the New U.S. Route 220 Southern Connector (Martinsville, VA)

Project Report
Project: UPC 110916

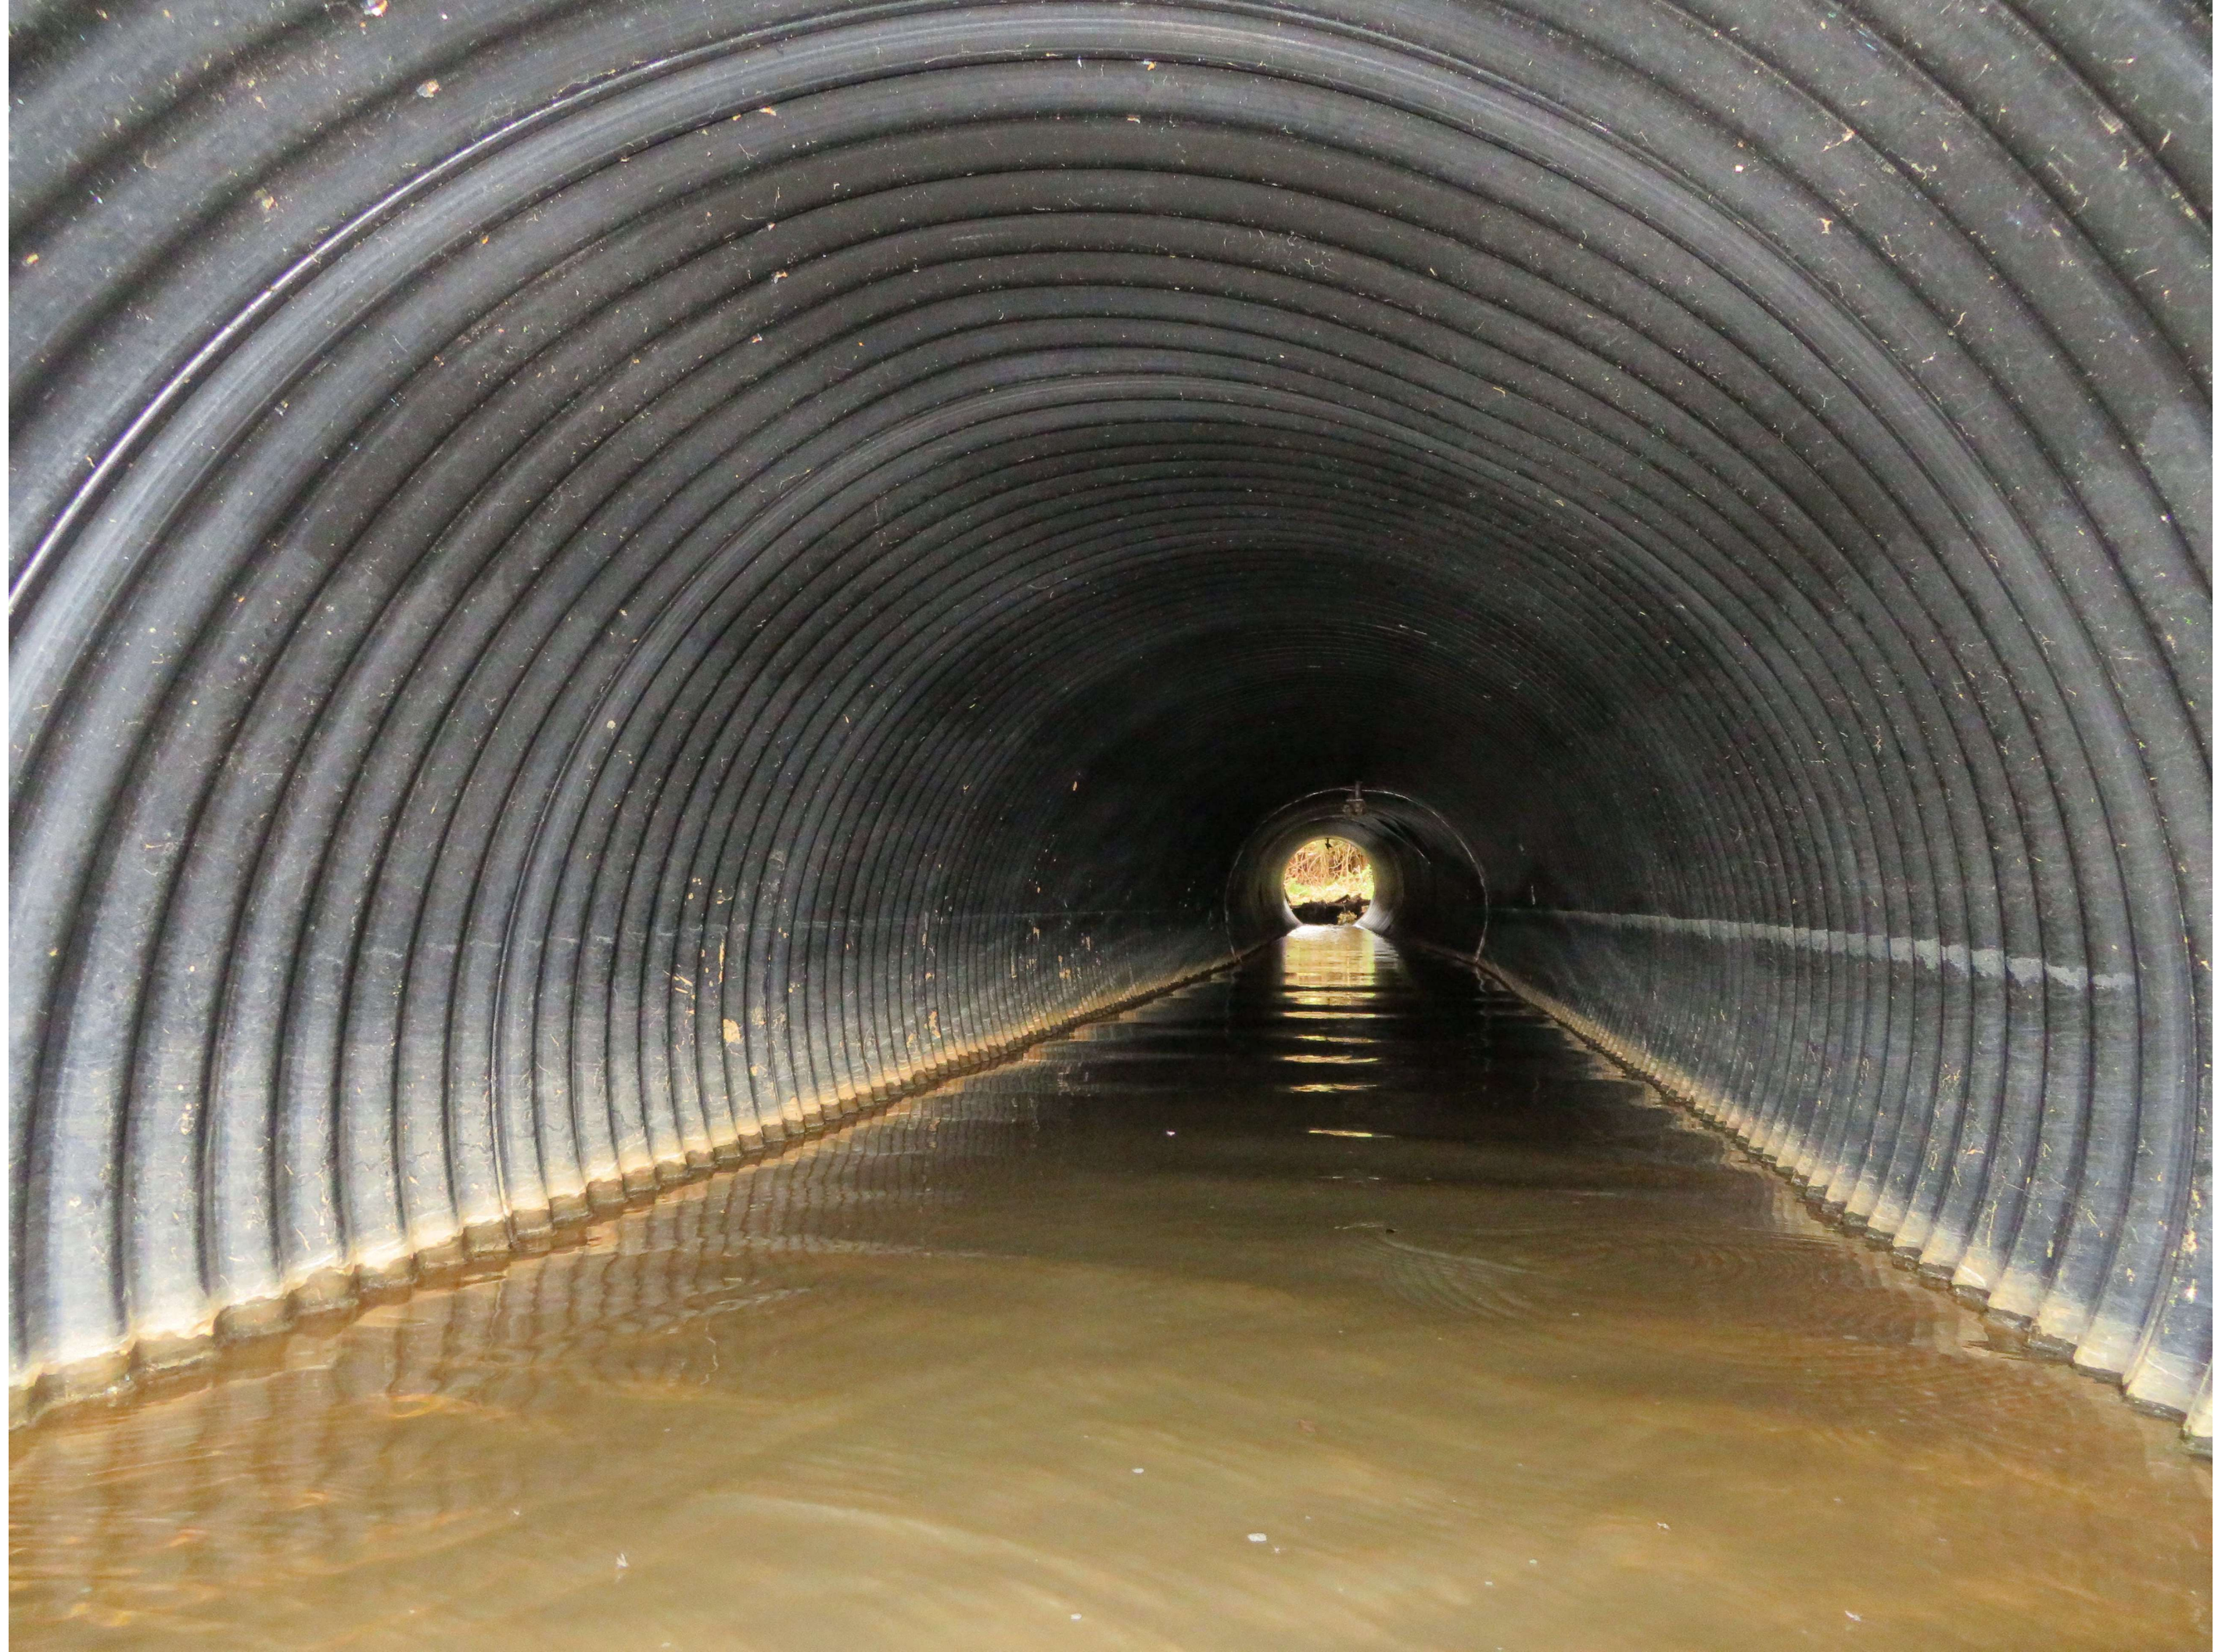
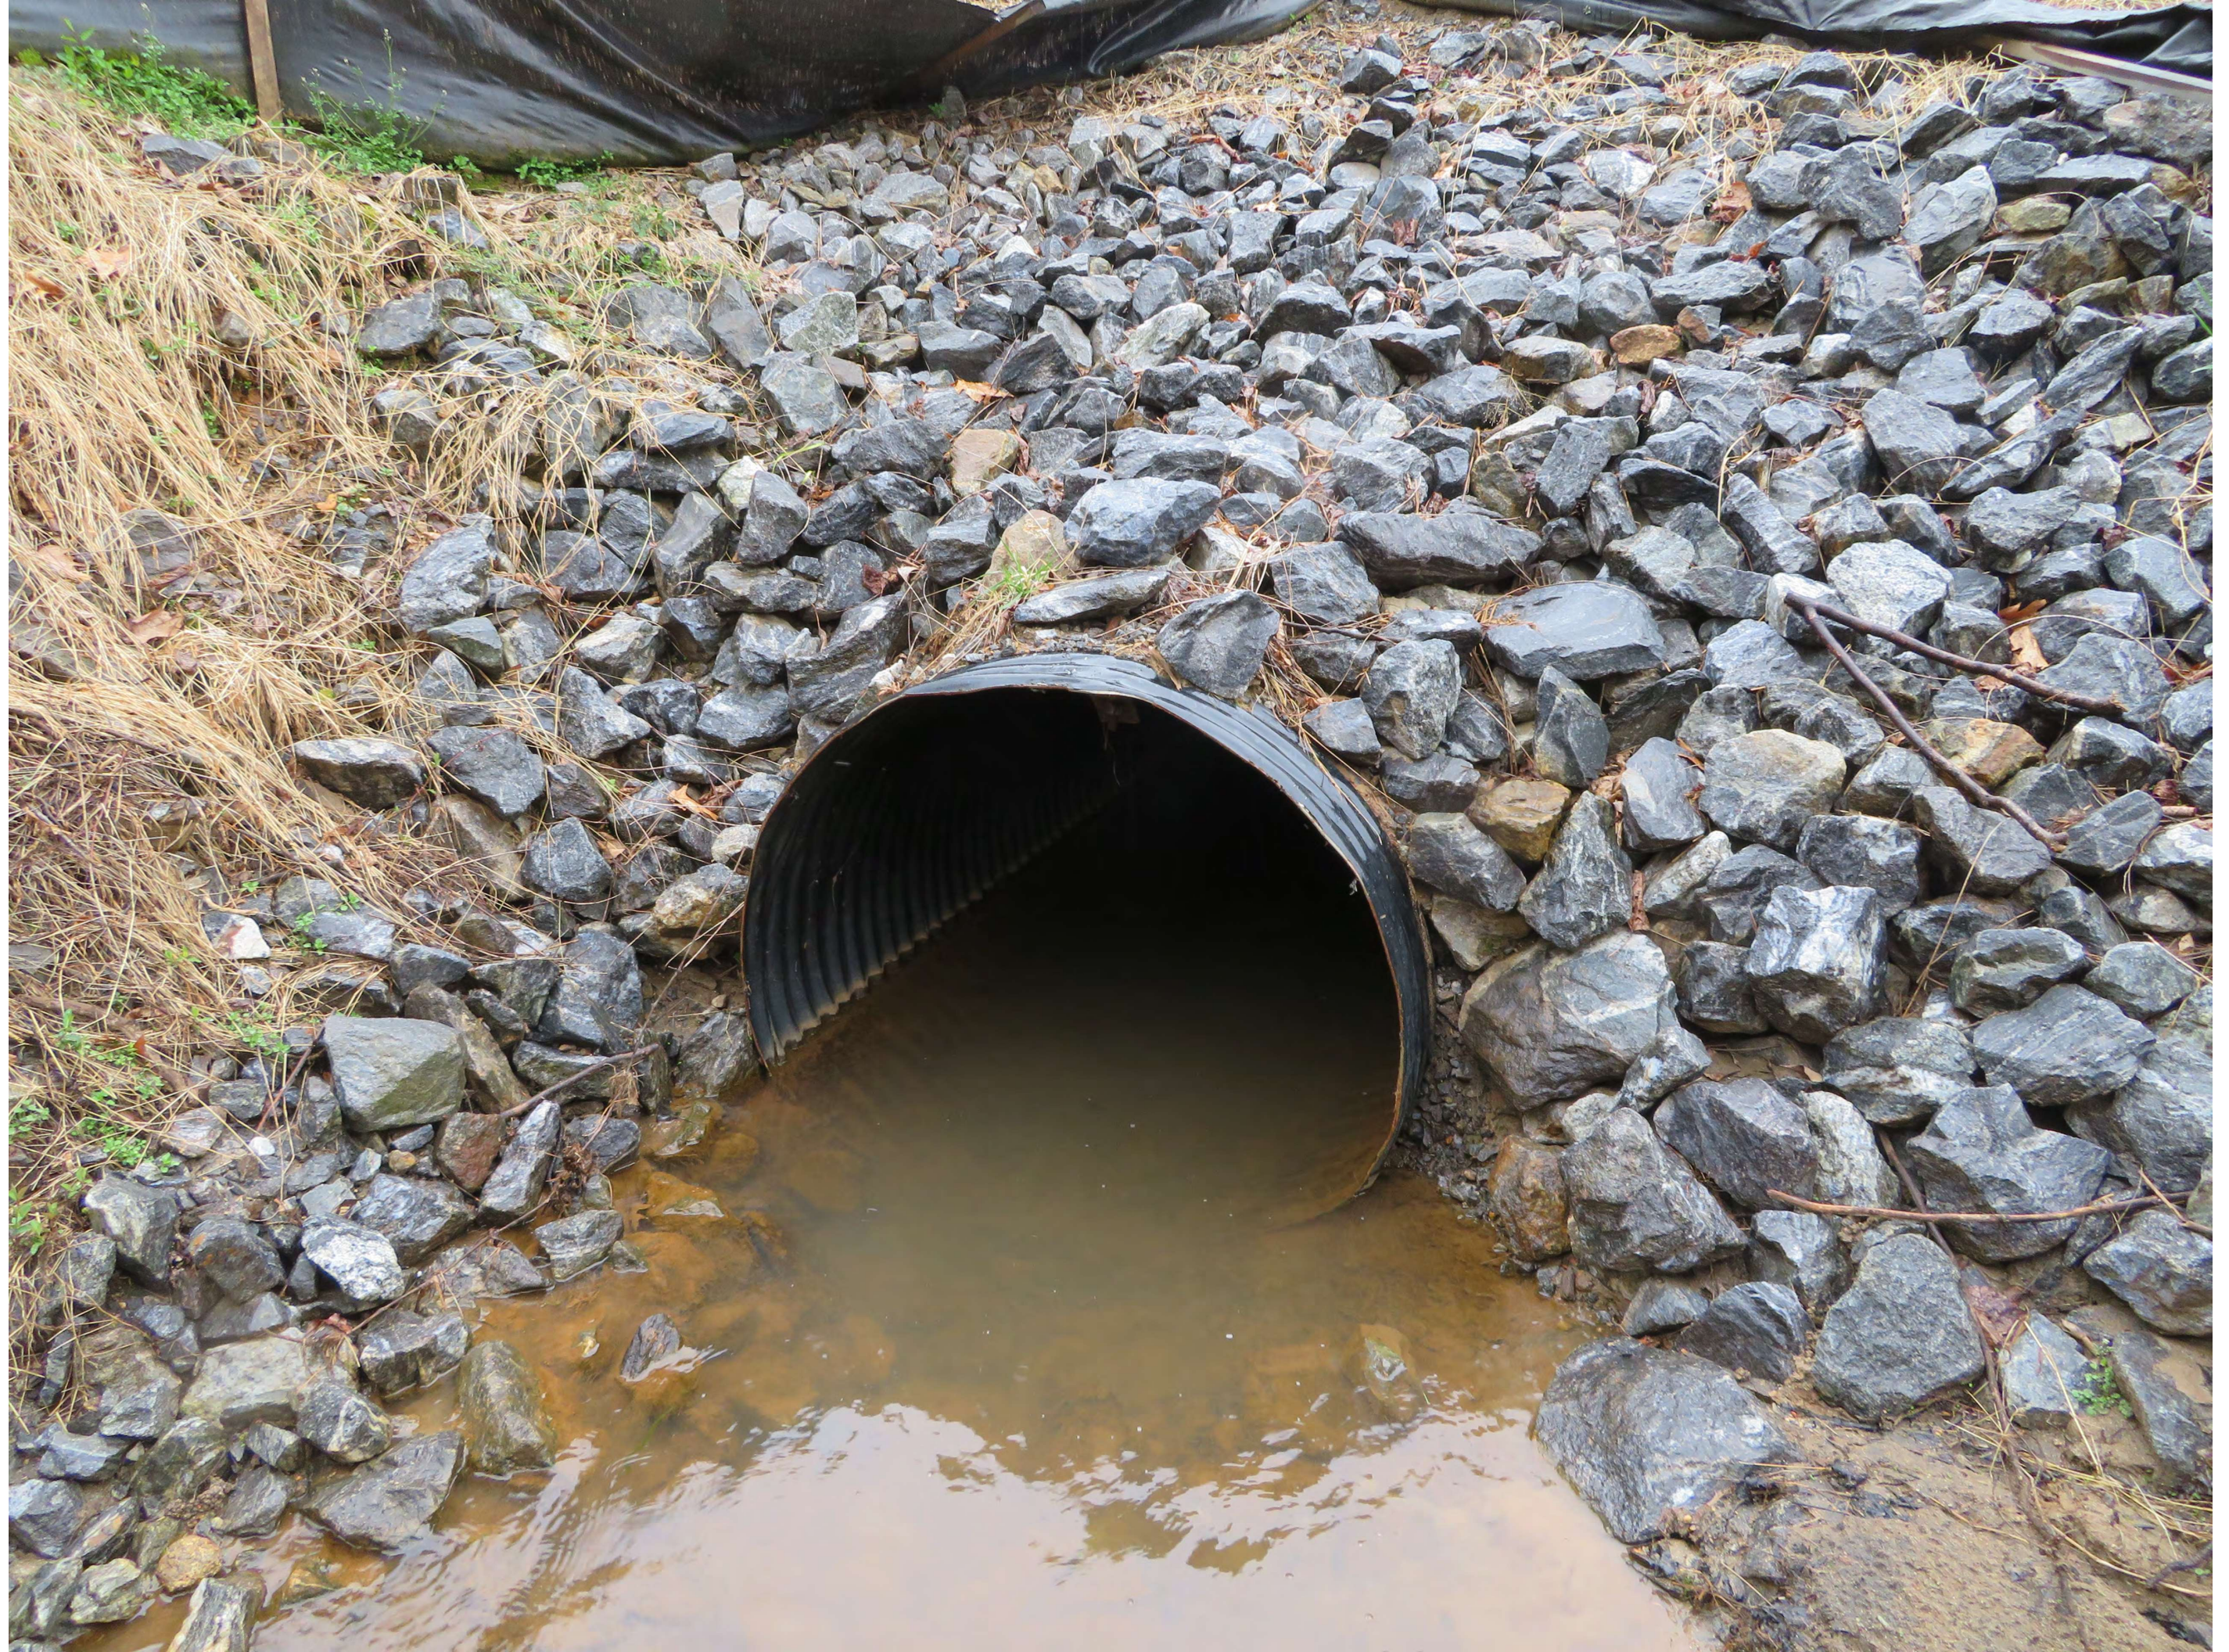
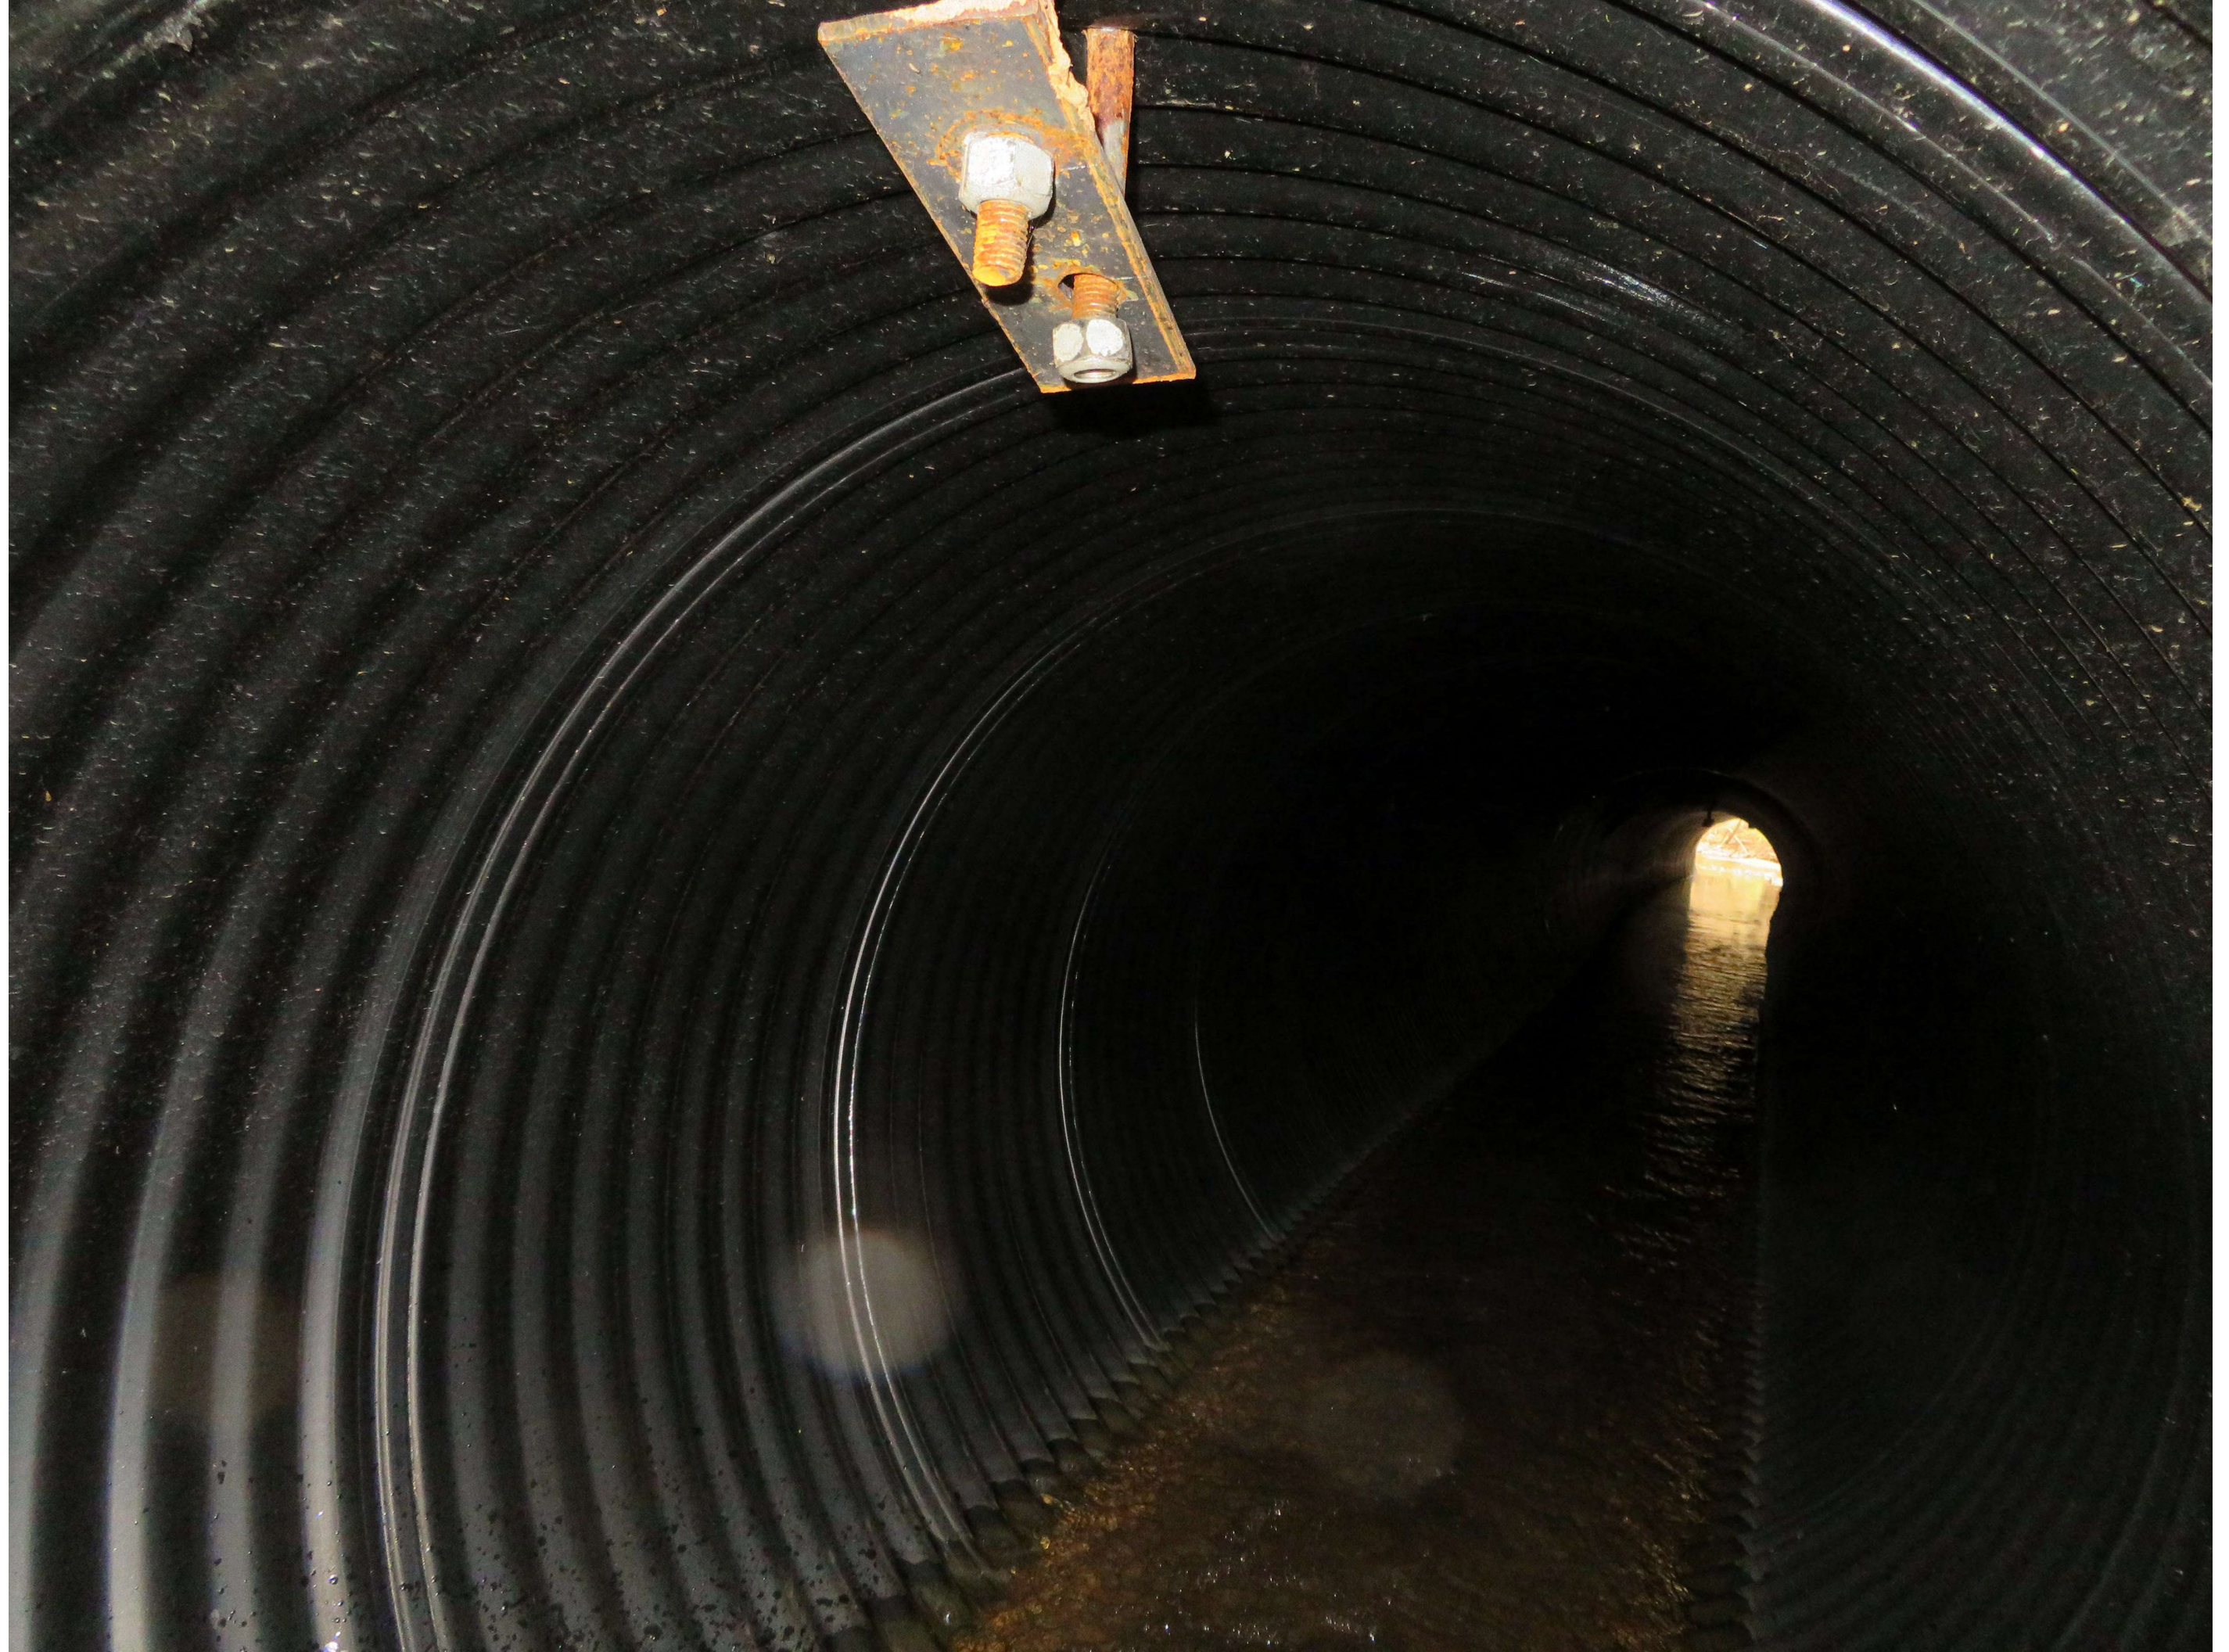
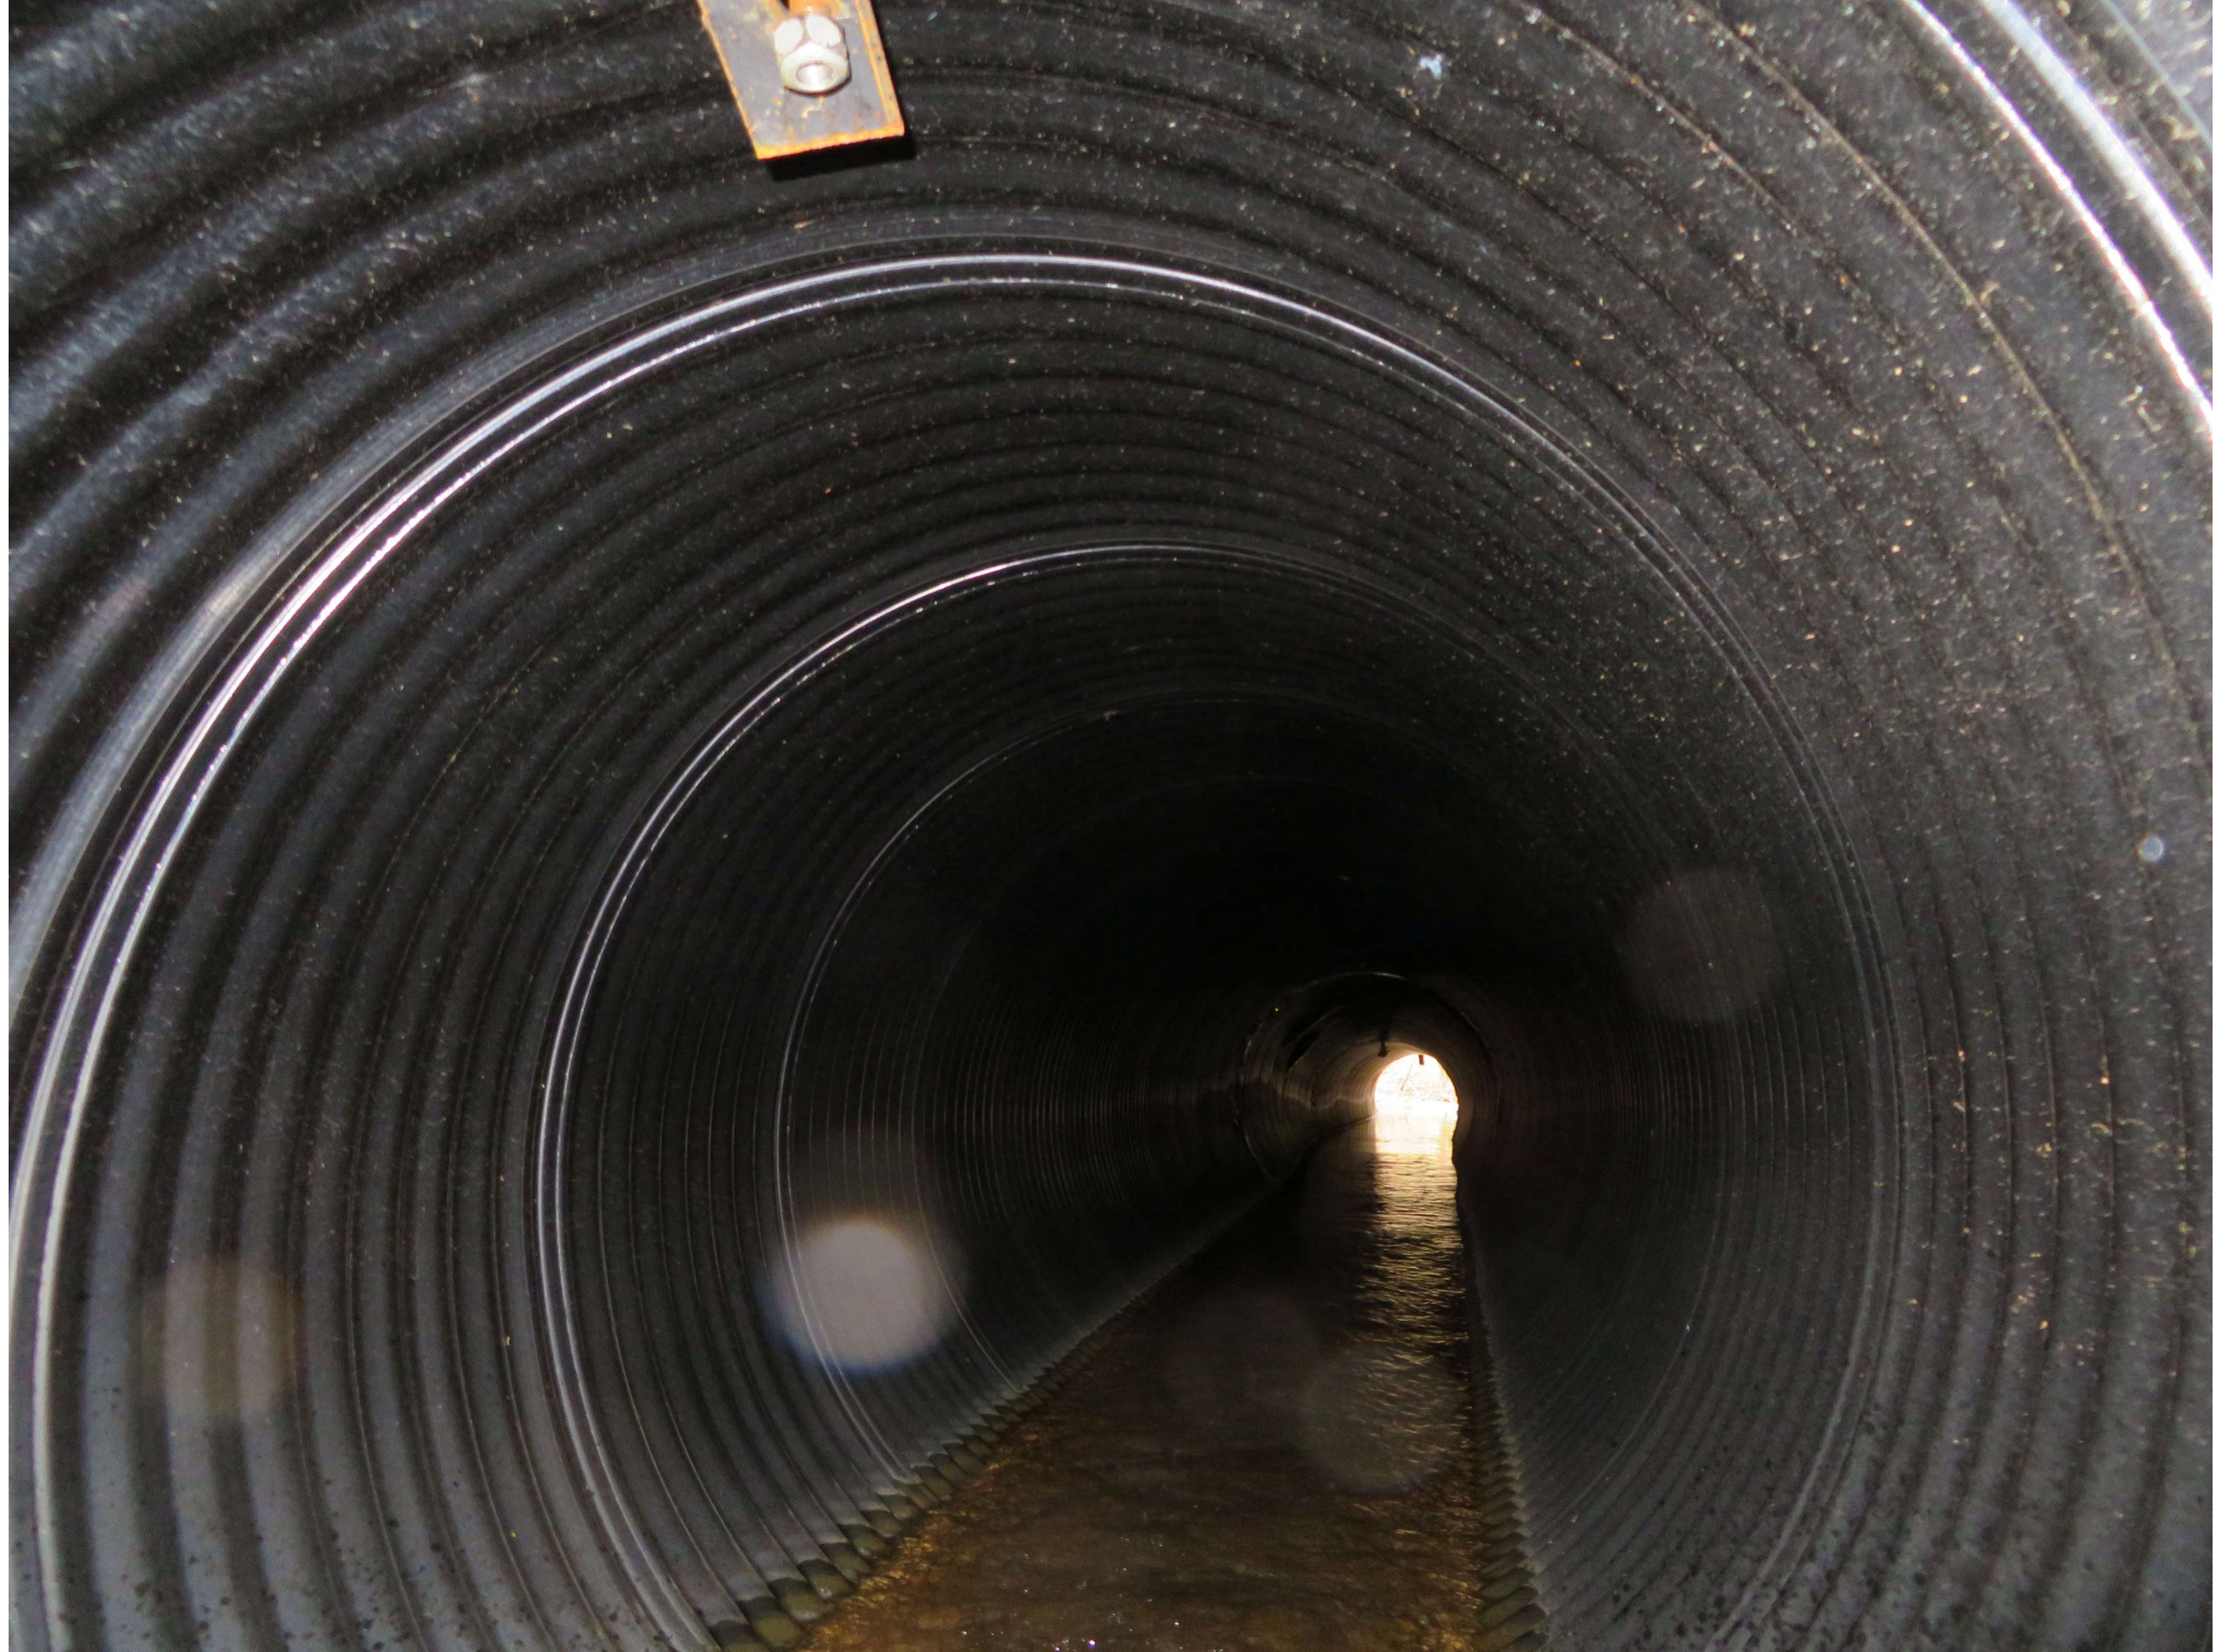
Notes No indications that bats are presently inhabiting the bridge. This location is the SB side of US 220/Marrowbone Creek crossing.			
Inventory Conducted By: <u>Scot Aitkenhead</u> Company/Organization: <u>Wallace Montgomery</u> Signature: <u><i>Scot Aitkenhead</i></u>			
District Environmental Use Only			
Date Received by District Environmental Manager: _____

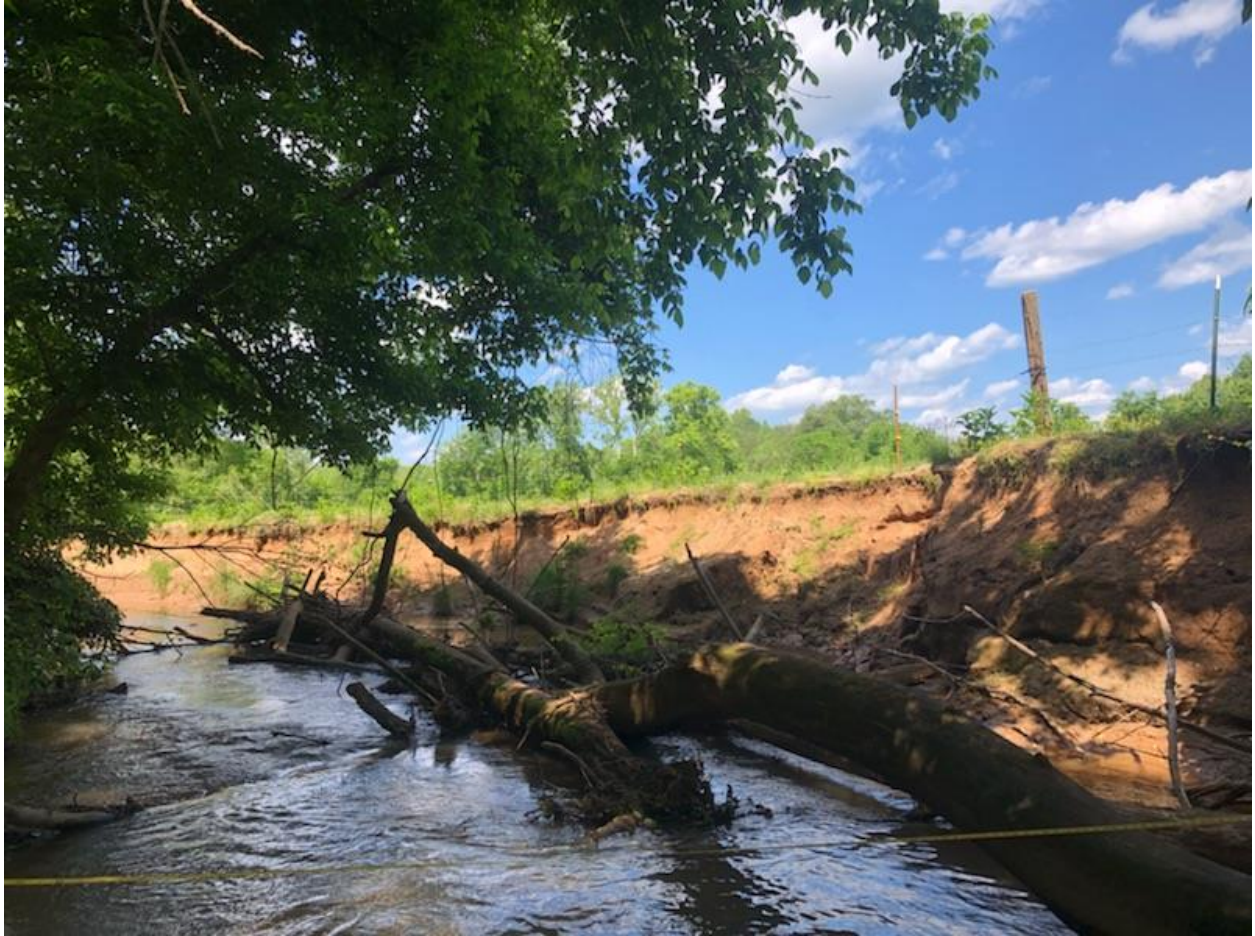
Figure 2. Unstable, eroding riverbank downstream of one of the proposed bridge construction locations (Alternative D) on Marrowbone Creek.

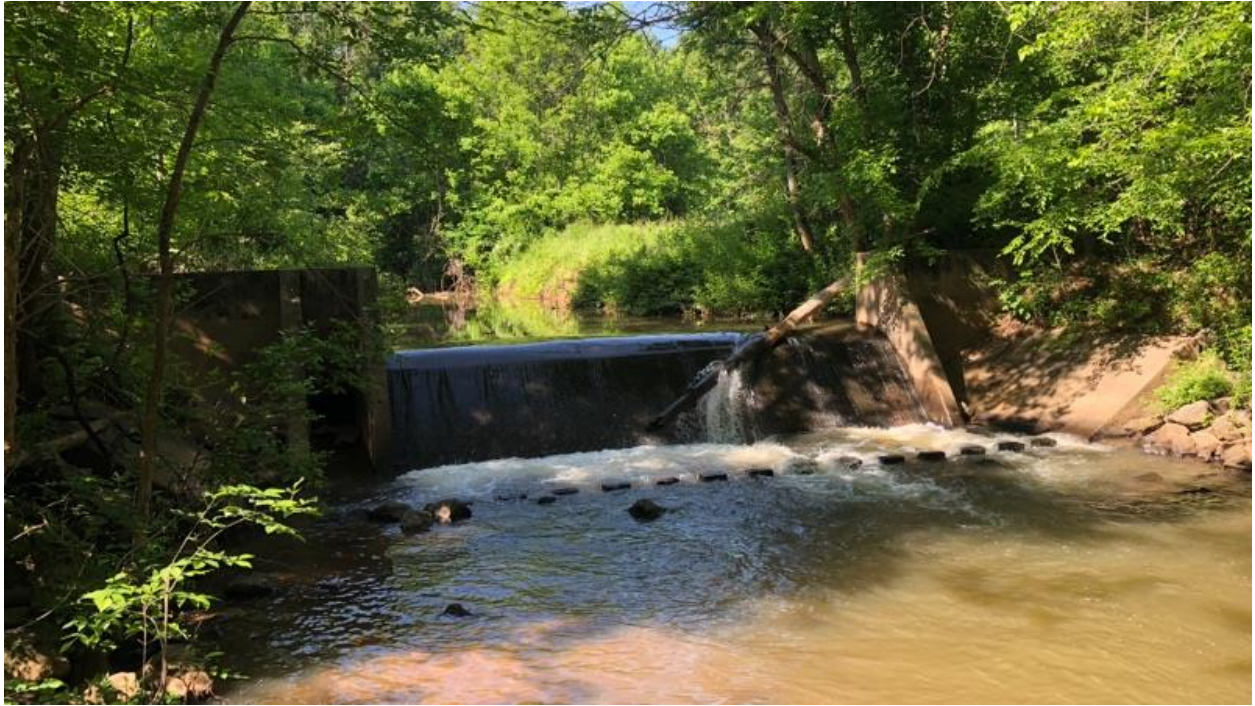
Figure 3. Low-head dam approximately 500 meters upstream of the Alternative D proposed bridge construction location (downstream of Alternative C) in Marrowbone Creek (viewed from downstream of the dam).

Based on these findings, Alternatives C and E seem to offer the best opportunities for conserving fish habitat within Marrowbone Creek. Bridge construction at Alternative C is unlikely to have major impacts on native fish communities because the riparian canopy downstream is already degraded, benthic habitats are fairly homogenous and dominated by fine sediment, and additional sediment from construction at Alternative C is likely to be trapped by the dam located just

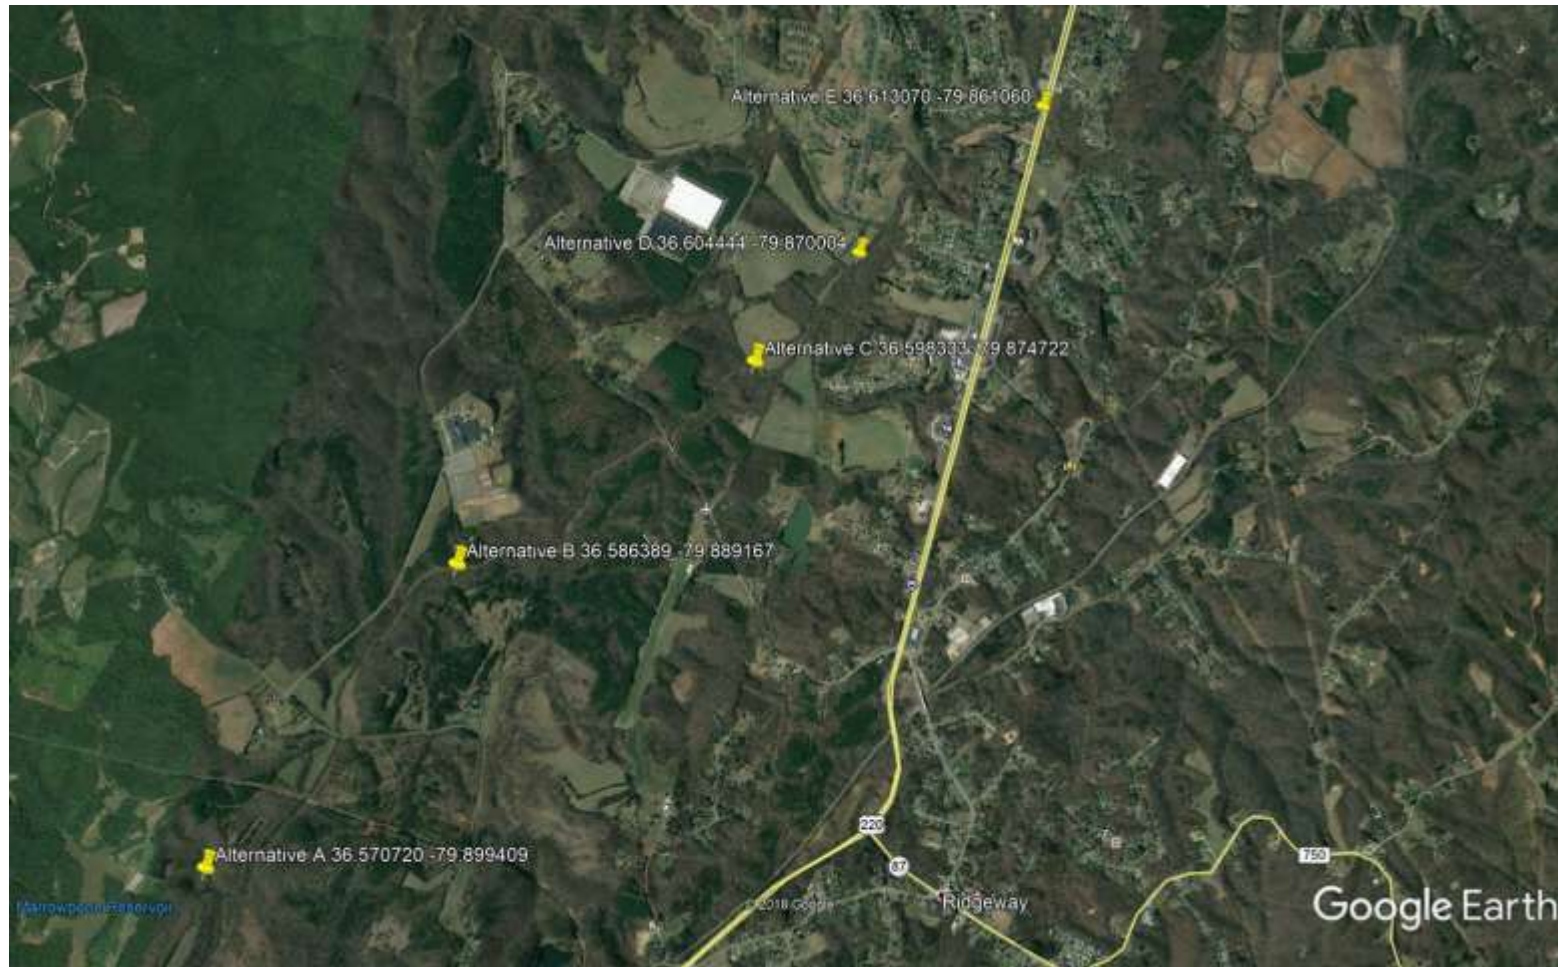
Figure 2. Mussel habitat assessment site at the Route 220 Bypass Alternative Route A crossing of Marrowbone Creek, Henry County, Virginia, surveyed on May 20, 2019.

The site was ≈ 900 m north from the driveway entrance at Route 689 of the residence of Mr. Ron Holt (Table 1, Fig. 1). Mr. Holt escorted us to a parking site at the edge of his pasture. From the parking place, we walked to the site through ≈ 280 m of pasture, then 220 m through thick forest to the site. The riparian zone was shaded due to complete coverage by lush undergrowth and trees. The channel was deeply incised, and bank heights were 3 m (VDOT Survey Collection Record – Marrowbone Creek – ALT A, Fig. 2). The bottom substratum was unsuitable for mussels, and consisted of loose, fine sand and silt with areas of fine gravel that were scattered within the reach. Submerged woody debris was common, and water depth was ≈ 0.3 m. No mussels were observed during a total of 1.0 h of search time (VDOT Survey Collection Record – Marrowbone Creek – ALT A, Table 1). Two muskrat middens were observed with small numbers of Asian clams (*Corbicula fluminea*). Live *C. fluminea* were common, but only in patches of consolidated fine gravel (Table 7). Crayfish and cyprinid minnows were uncommon.

Comments: Viewscopes only. Two muskrat middens – all Corbicula; riparian – thick, shaded canopy; deeply incised channel with 3 m banks; substrate very unstable – loose fine sand/silt with small areas of fine gravel where Corbicula were observed. Crayfish rare. Water depth mean about 0.3 m. Submerged woody debris common.

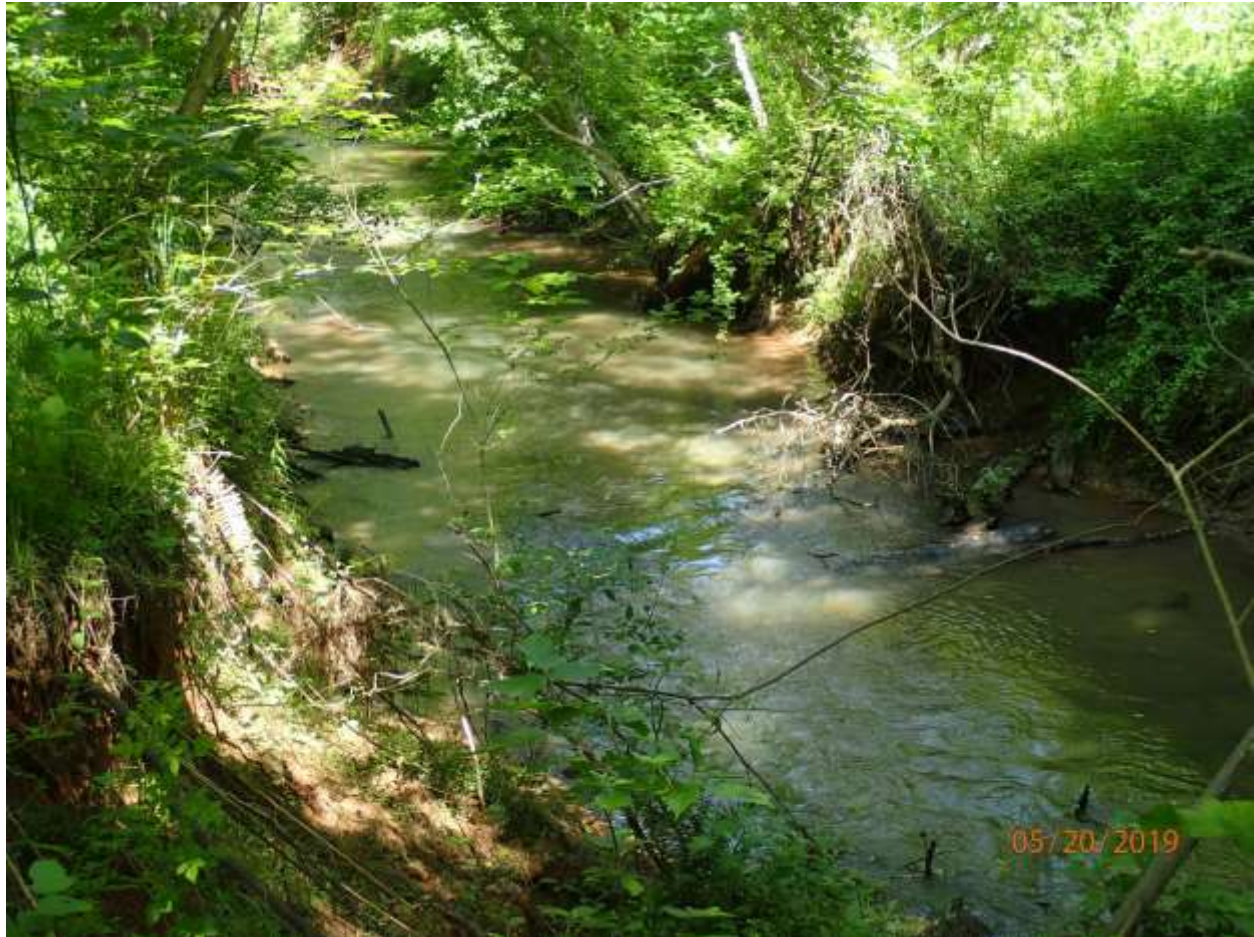
Figure 3. Mussel habitat assessment site at the Route 220 Bypass Alternative Route B crossing of Marrowbone Creek, Henry County, Virginia, surveyed on May 20, 2019.

We parked at the east side of Route 1060 at a gate that was ≈ 1000 m south of Magna Vista High School, alongside Marrowbone Creek (Table 1, Fig. 1). From the parking site, we hiked ≈ 540 m northeast along an overgrown farm road, then through young forest growth. The riparian zone was shaded by lush undergrowth and trees. The channel was deeply incised. The left and right descending bank heights were 2 and 1.5 m, respectively (VDOT Survey Collection Record – Marrowbone Creek – ALT B, Fig. 3). The bottom substrate was unsuitable for mussels, and consisted of very loose fine sand and silt with areas of fine gravel scattered within the reach.

Submerged woody debris was common, and water depth was ≈ 0.3 m. No mussels were observed during a total of 1.0 h of search time (VDOT Survey Collection Record – Marrowbone Creek – ALT B, Table 1). Live *C. fluminea* were uncommon, only in patches of consolidated fine gravel. Crayfish and fish fry were rare.

Comments: Viewscopes only. No muskrat middens. Corbicula – uncommon. Riparian – thick, shaded canopy; deeply incised channel – left descending bank 2 m, right descending bank 1.5 m; substrate very unstable – fine sand/silt with small areas of fine gravel where Corbicula were observed. Crayfish rare. Water depth mean about 0.3 m. Submerged woody debris common. Fish fry only were observed.

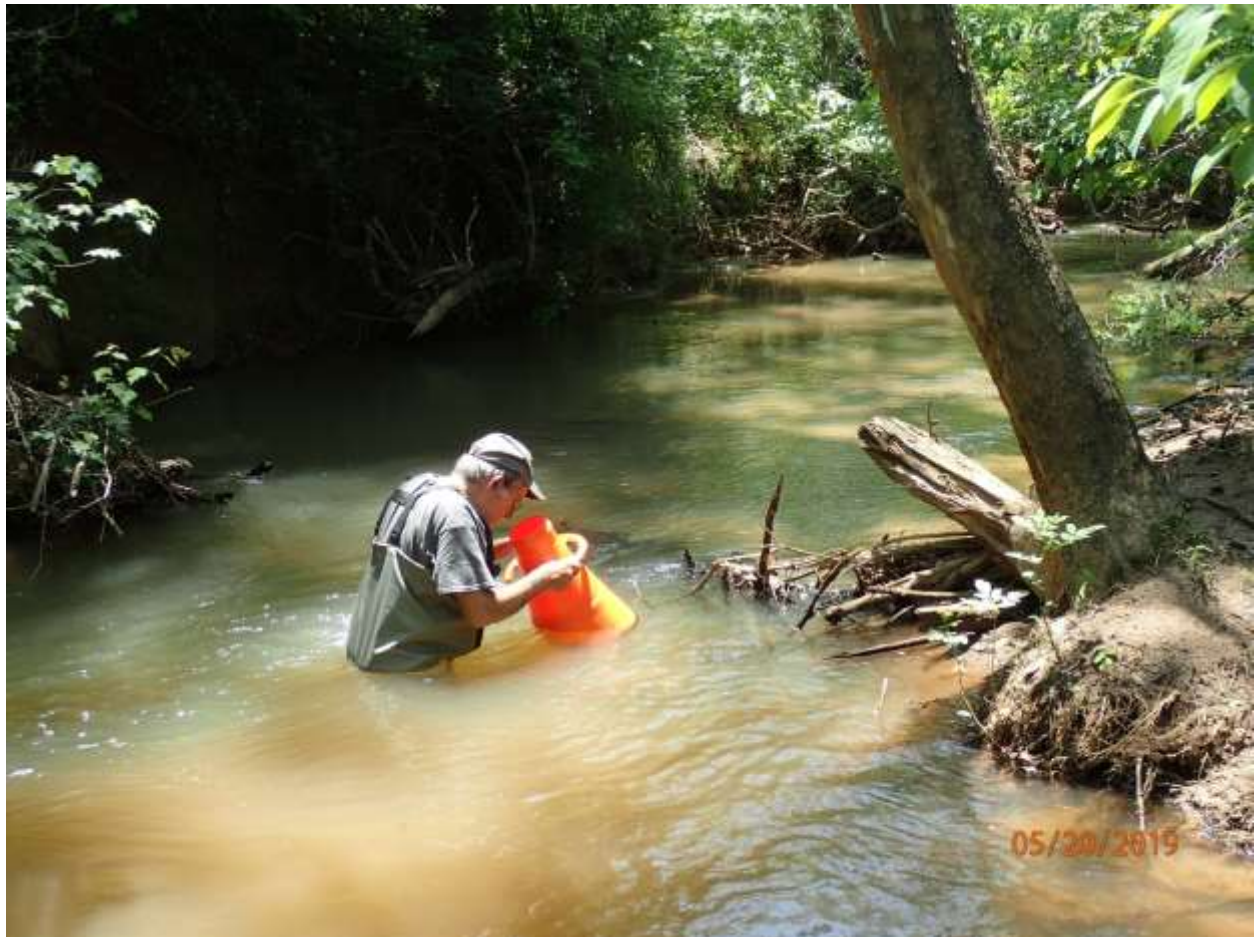
Figure 4. Mussel habitat assessment site at the Route 220 Bypass Alternative Route C crossing of Marrowbone Creek, Henry County, Virginia, surveyed on May 20, 2019.

The riparian zone was shaded due to complete coverage by lush undergrowth and trees. The channel was deeply incised, with banks that were about 2 m high (VDOT Survey Collection Record – Marrowbone Creek – ALT C, Fig. 4). Submerged wood debris and fallen timber were very common in the channel. The bottom substratum was unsuitable for mussels, consisting of loose, fine sand and silt, with no gravel. Water depth was ≈ 0.2 m. No mussels were observed during the 0.33 h of search time (VDOT Survey Collection Record – Marrowbone Creek – ALT C, Table 1). Live *C. fluminea* were uncommon, but no crayfish or fish were observed.

Comments: Viewscopes only. No muskrat middens. Corbicula – uncommon. Riparian – thick, shaded canopy; deeply incised channel – left descending bank 2 m, right descending bank 2 m; substrate very unstable – fine sand/silt with small areas of fine gravel where Corbicula were observed, and sparse rock outcrops. Water depth mean about 0.2 m. Submerged woody debris and fallen logs common. Crayfish not observed.
